INTRODUCTION

San Onofre Nuclear Generating Station (SONGS) performed a visual assessment of three multi-purpose canisters (MPCs) from March 21 - 23, 2019. This report includes the following:

SONGS HI-STORM MPC Visual Assessment Report

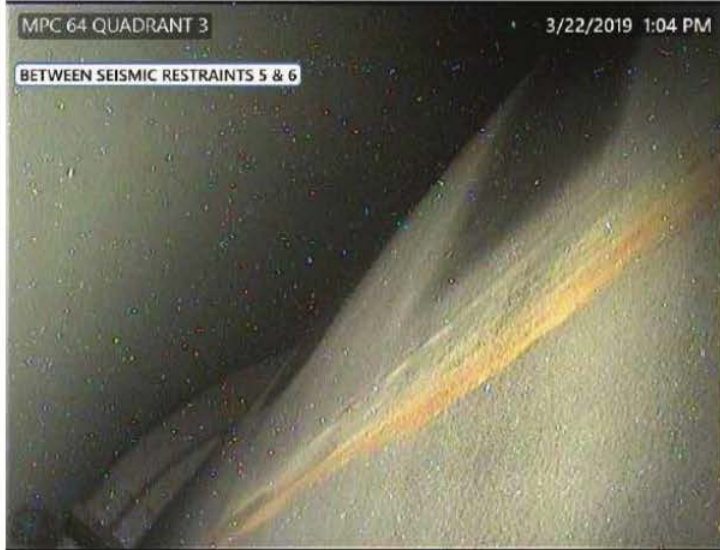
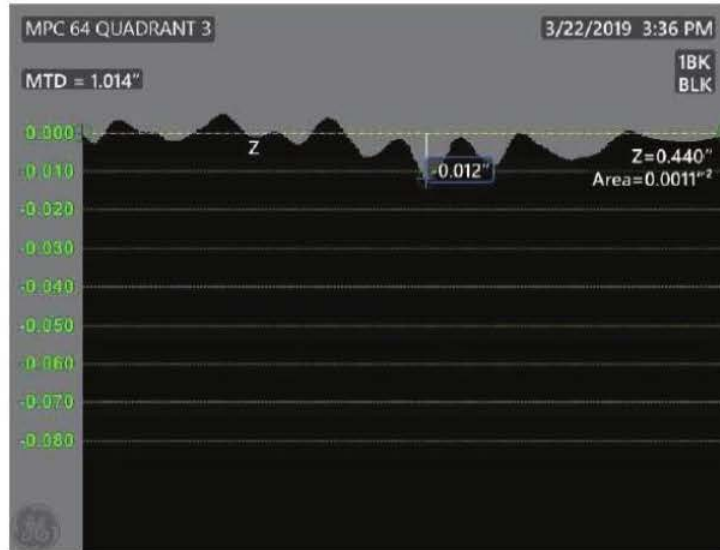
MPC S/N	Description	Circumferential Location ³	Length ¹ (inches)	Width ² (inches)	Depth ² (inches)
067	No areas of interest from downloading operations provided a measurable depth (< 0.001 inches)				
064	Carbon Steel Contamination	Between SR5 – SR6	30	2	0.012
064	Wear Mark	Between SR5 – SR6	6	1	0.009
064	Wear Mark	Between SR5 – SR6	6	1	0.009
064	Wear Mark	Between SR5 – SR6	8	1	0.009
064	Wear Mark ⁴	Between SR5 – SR6	1	4	0.009
064	Wear Mark	Between SR6 – SR7	15	5	0.011
064	Wear Mark	Between SR7 – SR8	30	2	0.003
072	Carbon Steel Contamination ⁴	Between SR1 – SR2	4	8	< 0.001
072	Wear Mark	Between SR1 – SR2	0.002 square inches ⁶		0.007
072	Wear Mark ⁴	Below SR1	> 120	~ SR4 wear mark	~ SR4 wear mark
072	Wear Mark ⁴	Below SR4	> 120	0.107 to 0.192	0.016 ⁵
072	Wear Mark	Below SR4	12-24	< 0.192	0.026
072	Wear Mark	Below SR5	24-36	~ SR4 wear mark	~ SR4 wear mark

The figures above correspond to the carbon steel conamination in the shield ring induced wear mark between MPC Inner Seismic Restraints 5 and 6 as documented in Table 1 in the body of the report.

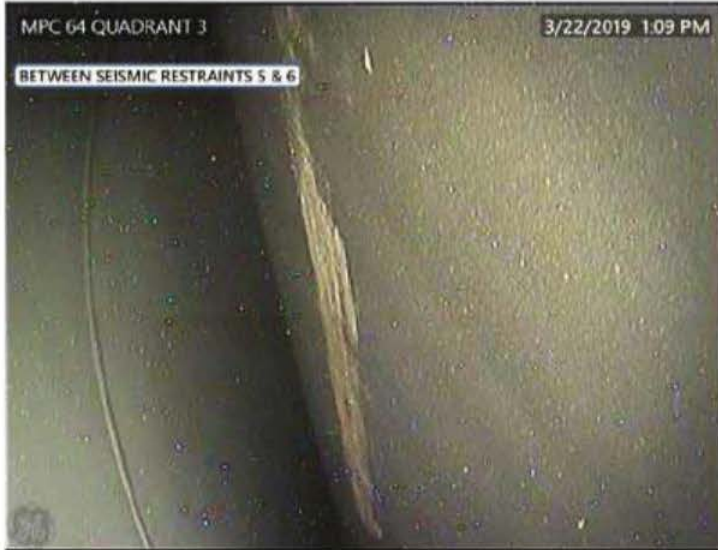
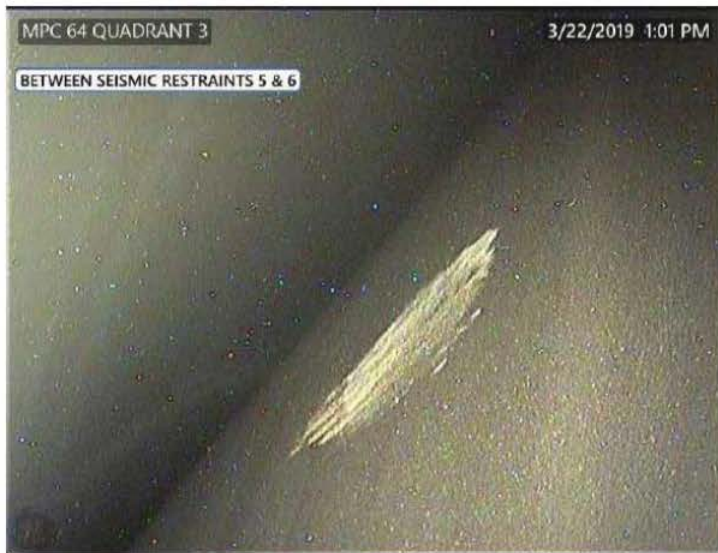
The figures above correspond to the shield ring induced wear marks identified between MPC Inner Seismic Restraints 5 and 6 as documented in Table 1 in the body of the report.

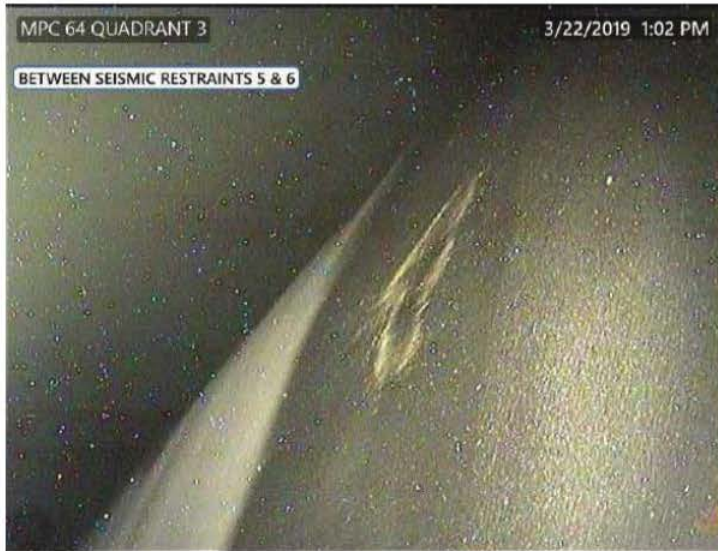
Wear mark is located within the MPC circumferential weld.

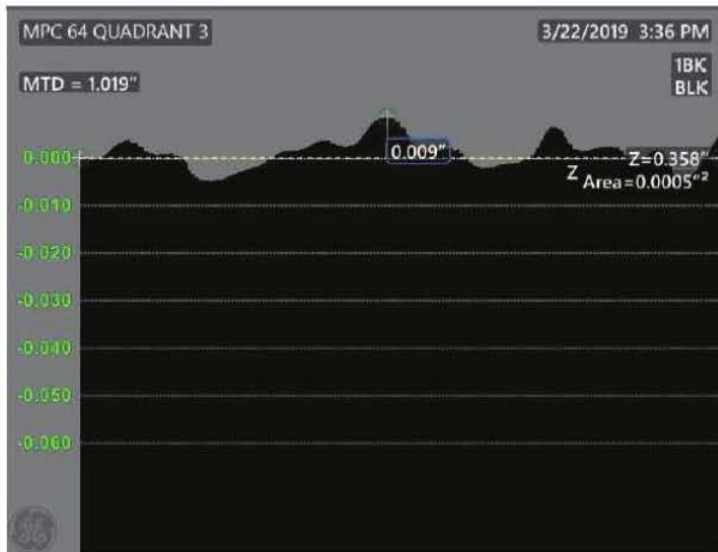
The figures above correspond to the shield ring induced wear marks identified between MPC Inner Seismic Restraints 5 and 6 as documented in Table 1 in the body of the report.

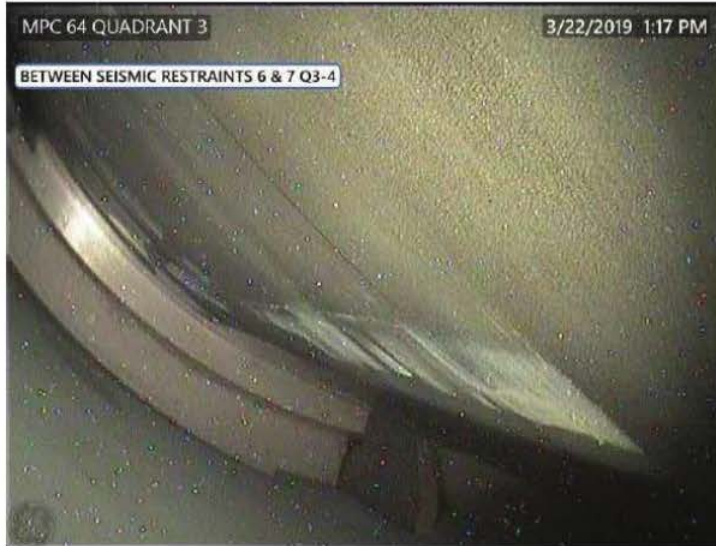
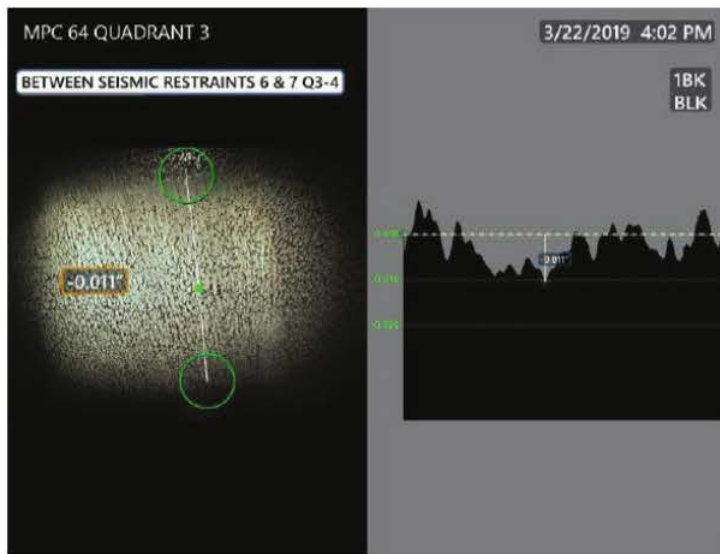
The figures above correspond to the shield ring induced wear marks identified between MPC Inner Seismic Restraints 6 and 7 as documented in Table 1 in the body of the report.

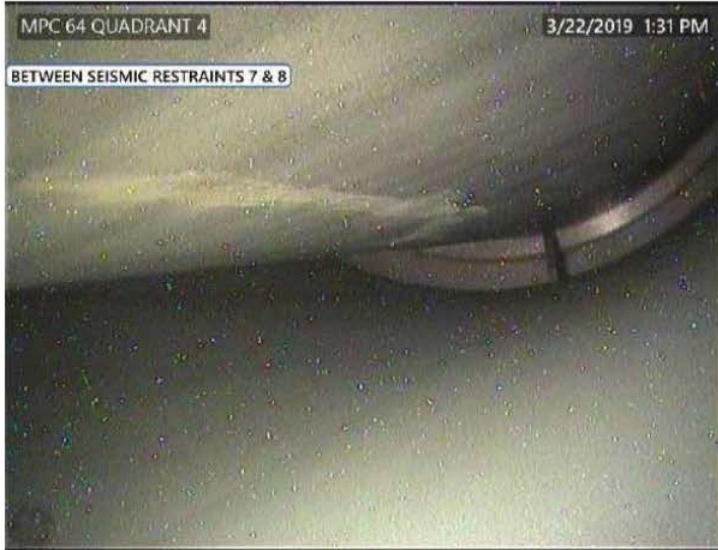
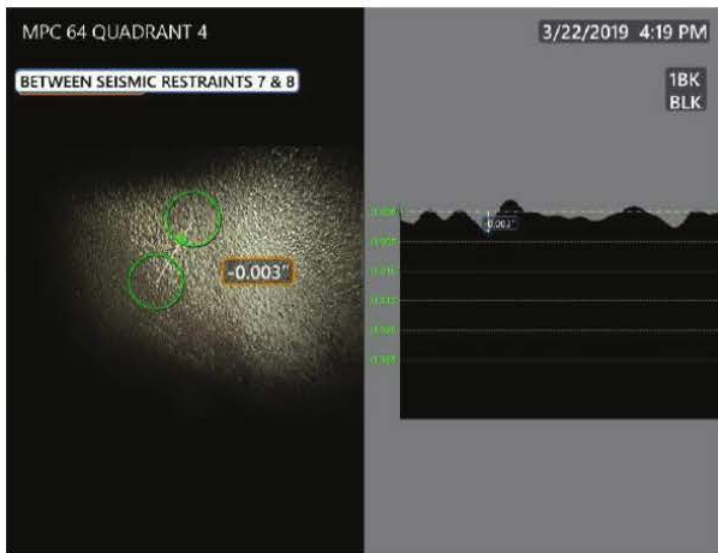
The figures above correspond to the shield ring induced wear marks identified between MPC Inner Seismic Restraints 7 and 8 as documented in Table 1 in the body of the report.

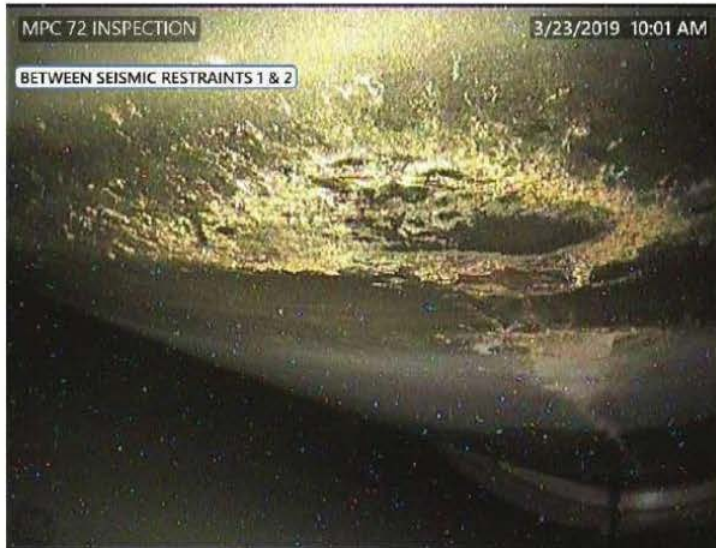
Carbon Steel Contamination within the HAZ of the MPC circumferential weld

The figure above corresponds to the shield ring induced carbon steel contamination identified between MPC Inner Seismic Restraints 1 and 2 as documented in Table 1 in the body of the report. There was no measurable depth for this location.

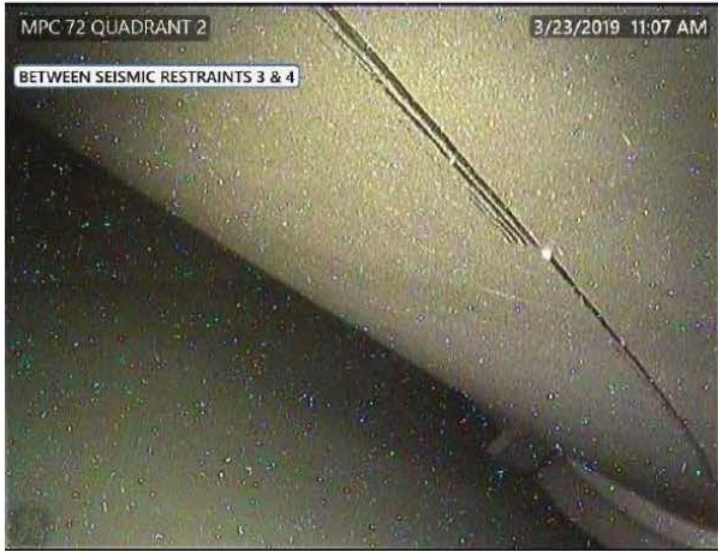
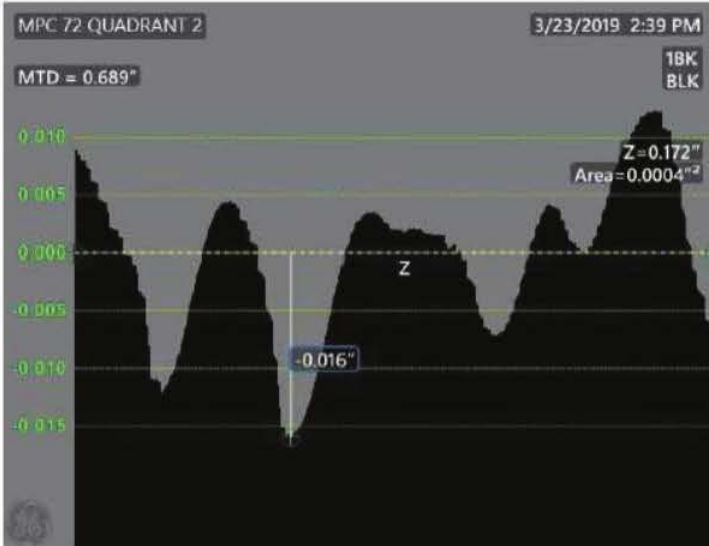
The figures above correspond to the greater than 120 inch long SR induced wear mark identified below MPC Inner Seismic Restraint 4 as documented in Table 1 in the body of the report.

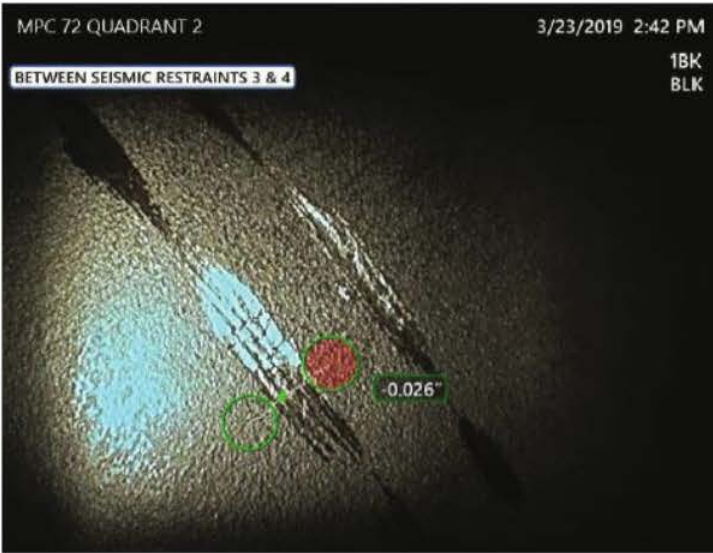
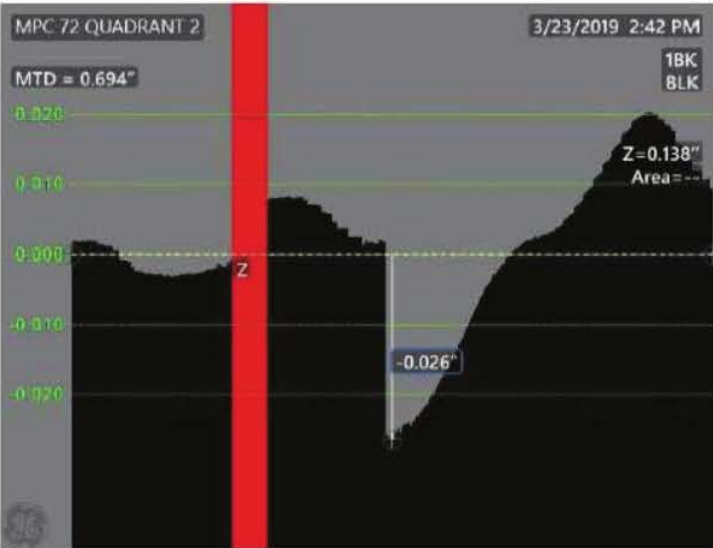
Three MPCs underwent visual assessments where various types of surface irregularities were identified. The deepest surface irregularity identified as a result of downloading operations was a wear mark due to contact with an MPC inner seismic restraint and had a maximum depth of up to 0.026 inches. Holtec Report HI-2188437 (Ref. 7) describes that the SONGS HI-STORM MPC has 0.175 inches of available margin for localized losses of shell thickness to remain in compliance with all applicable ASME Boiler & Pressure Vessel Code requirements. Based on the available margin, there is still 0.149 inches available for the worst-case observed surface irregularity. Additionally, with worst-case wear mark having a margin of almost 7 times compared to the allowable limit, the scope of the visual assessment is considered adequate. Therefore, even with incidental contact during downloading operations, the SONGS HI-STORM MPCs remain in compliance with all applicable ASME Boiler & Pressure Vessel Code requirements.

The red bar represents background noise in the characterization

The figures above correspond to the 12 to 24 inch long SR induced wear mark identified below MPC Inner Seismic Restraint 4 as documented in Table 1 in the body of the report.
