# **Seismic Event**

# Seal ageing

# Stress corrosion cracking

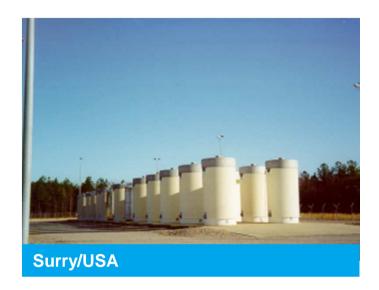
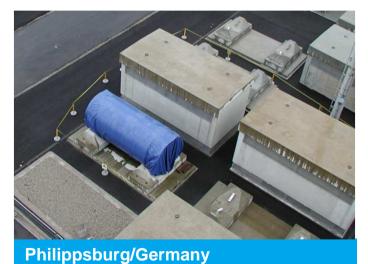
The DCI cask can be stored in a horizontal as well as in a vertical position.

For seismic events the DCI casks can be fixed at the surface using a trunnion fixation.

The DCI cask has four trunnions at the bottom side where the cask can be fixed.

Even when there is no fixation on the surface and a cask tipps over during a severe earthquake, the damage to the DCI cask is negligible.

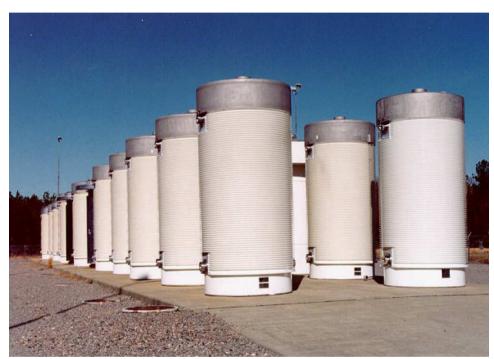
Open air storage by INEEL of CASTOR® V/21

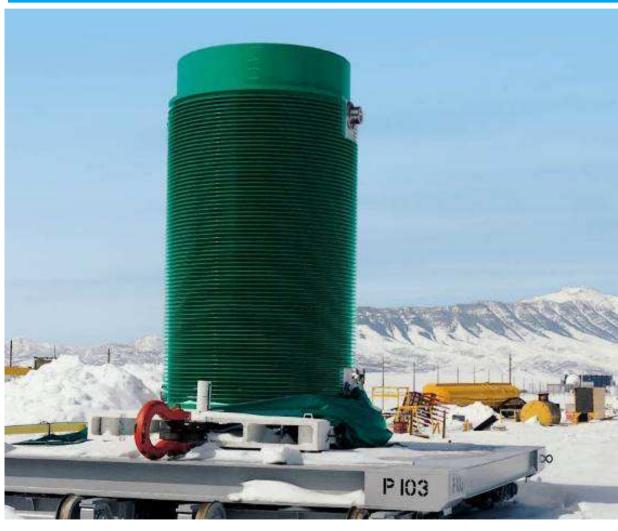
#### CASTOR® V/21

"There is no evidence of degradation of the CASTOR® V/21 cask systems important to safety from the time of initial loading of the cask in 1985 up to the time of testing in 1999"

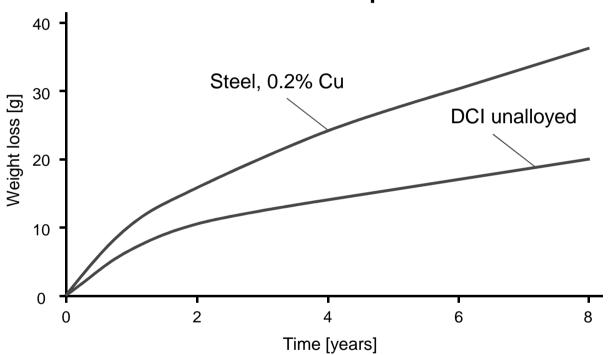
- DCI provides favourable characteristics for long-term integrity against corrosion due to the structural material (graphite pearlite) and the increasing passivation layer
- Hence, the relevant safety requirements can be assured even under long-term aspects

- Nodular graphite makes the difference
- Corrosion resistance highly advantageous for final storage

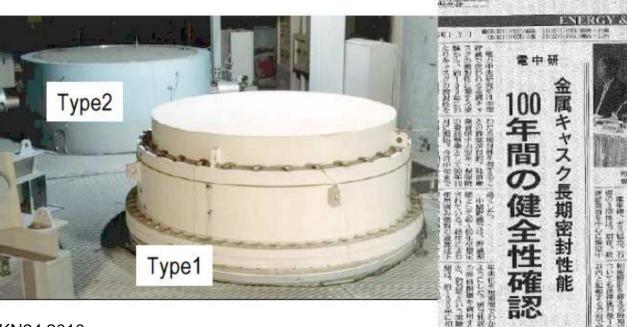
- To confirm long-term confinement of metal gaskets under normal storage condition
  - Assessed by experimental data of two full-scale cask lids & analysis
  - Tests continuing for more than 19 years under accelerated condition (Gasket temp. = 140, 130 °C const.)
  - Equivalent storage period : more than 60 years (Actual condition : Gasket temp. decrease)

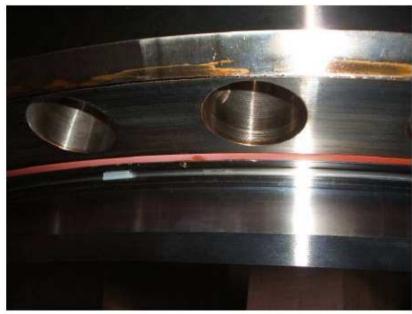
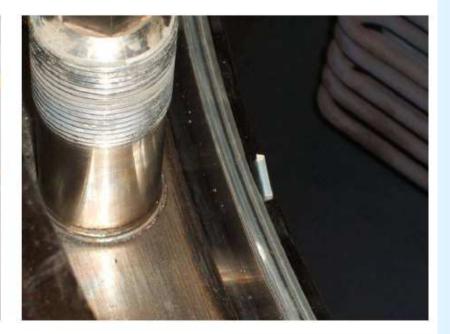
To confirm the characteristics of metal gaskets after thermal aging

- Open the lids
- Verification of components Elastomer Gasket, Silver Gasket, Aluminum Gasket Tightening bolt, Pressure gauge, Surface condition of the flange and so on.

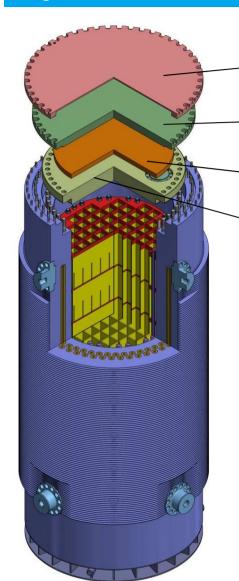
Protection lid

Secondary lid

Moderator plate

Primary lid

NiFeweld material

Base material EN-GJS-40

Microstructure of welded zone (etched)

- Change the seals of the secondary lid
   the shielding protection during this procedure is still given
   by the primary lid and the moderator plate
- Welding of the secondary lid to the cask
   this procedure is qualified and licenced by the BAM (German authority);
   the shielding protection during this procedure is still given
   by the primary lid and the moderator plate

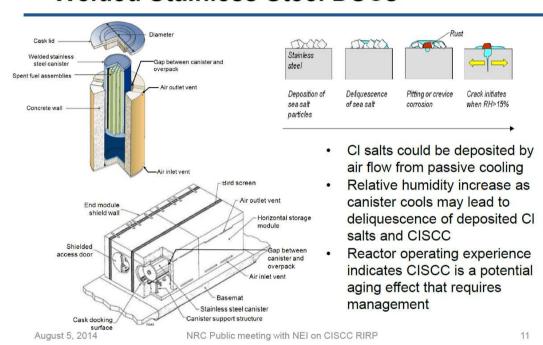
## Potential for SCC of Welded Stainless Steel DSCs

- DCI with chloride-containing solutions is no critical corrosion system for SCC; DCI has a good corrosion resistance against salts and solution of salts
  - ⇒ less actions for aging management
- Impurities and stresses from welds increase the susceptibility for SCC
  - ⇒ CASTOR® and TUK cask bodies have no welds
- Experience from NRC:
