SONGS Used Fuel Management - Defense in Depth

White paper for SONGS CEP

Prepared for: San Onofre 2 & 3

SONGS Used Fuel Management – Defense in Depth

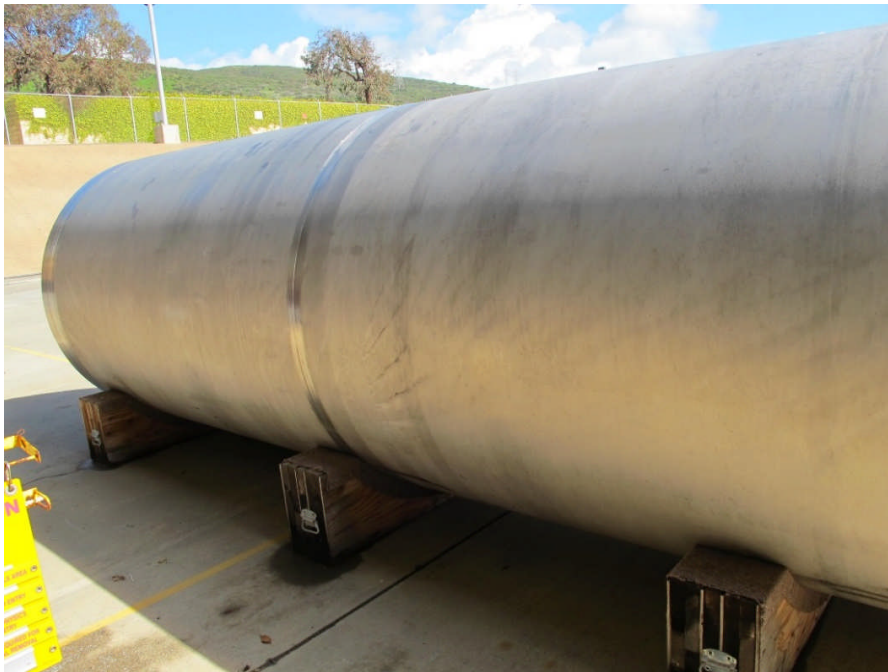
The welded stainless steel canisters used in the dry storage systems at SONGS provide a second barrier to release of radioactive materials. After the used fuel assemblies are loaded into a canister, water is removed and the canister is filled with helium gas and welded closed. The SONGS canisters provide a 5/8 inch (16 mm) thick, all welded, highly corrosion resistant stainless steel containment barrier around the used fuel assemblies. The helium gas placed inside the canister provides a chemically inert atmosphere which eliminates the potential for corrosion due to a moist air environment. The effectiveness of the canister as a second barrier is significantly enhanced by the absence of water inside the canister since there is no water available to transport soluble radioactive fission products out of a defect in a fuel rod. A SONGS used fuel canister is shown in the figure below.

Figure 4. Used Fuel Canister at SONGS

Used fuel canisters at SONGS contain 24 or 37 fuel assemblies. Canisters are welded shut and provide a second layer of defense-in-depth to help prevent the release of radioactive material. To minimize the risk of chloride induced stress corrosion cracking, canisters at SONGS are fabricated from 316L stainless steel, which is highly corrosion resistant.

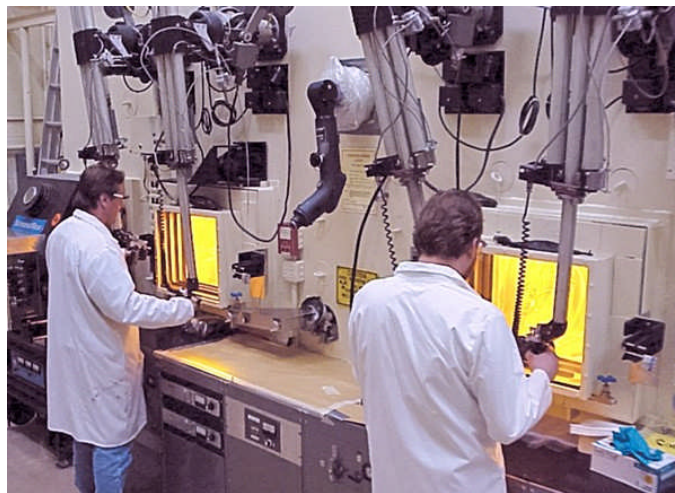
Transport casks have been used to ship severely damaged fuel, such as fuel from Three Mile Island, to shielded “hot cell” facilities at DOE National Laboratories (Reference 20). The DOE recently identified a large existing hot cell facility (Test Area North) on the Idaho National Laboratory (Reference 21) that could be dedicated to repackage commercial used fuel canisters. A “hot cell” is a facility with thick (3 feet or more) walls that provide enough shielding to protect workers from the radiation emitted by used fuel assemblies. Shielded lead glass windows and remote handling devices allow workers to cut, weld and perform detailed examinations on used fuel in a dry environment inside the hot cell as shown in the Figure 9 below. Hot cell facilities have been used for nuclear research and development for over 60 years.

Figure 9. Hot Cell Facility at BWXT (Reference 22)
