September 20, 2013

SUBJECT: SAN ONOFRE NUCLEAR GENERATING STATION – NRC CONFIRMATORY
            ACTION LETTER RESPONSE INSPECTION 05000361/2012009 AND
            05000362/2012009

2. Independent Evaluation of San Onofre
     Nuclear Generating Station (SONGS)
     Steam Generator Tube Wear Problems

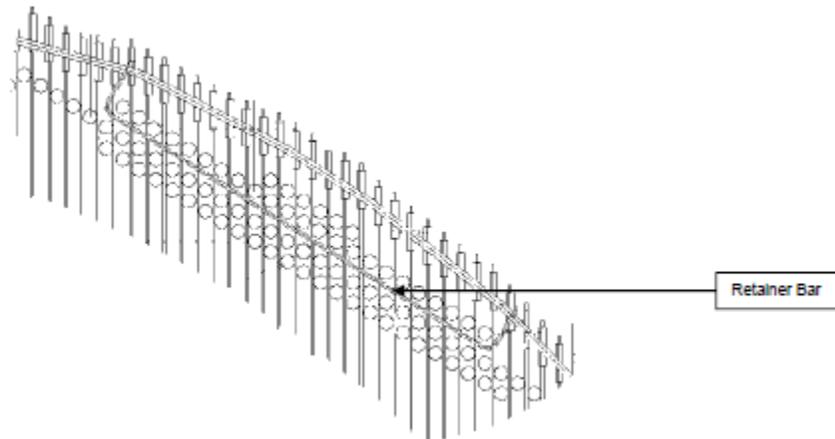
Retainer Bar

The licensee requested Mitsubishi to conduct an evaluation of the tube-to-retainer bar wear as a result of the wear indications found in the Unit 2 steam generators. Mitsubishi's evaluation determined that the wear was the result of movement of the retainer bar located at anti-vibration bars 2 and 3 on the hot leg side of the U-bend and anti-vibration bars 10 and 11 on the cold leg side. A review of the retainer bars at these locations revealed that the replacement steam generator retainer bars were significantly longer (24.02 inches in length) when compared to other steam generator designs (7-13 inches in length). In addition, the natural frequency associated with the longer, thinner retainer bars was significantly (approximately 5 times) less than the other steam generator designs reviewed during the evaluation. The licensee determined that the mechanical root cause of the wear was the combination of the longer length and smaller diameter (0.187 inches) retainer bar natural frequency and the increased flow velocities, which contributed to a flow-induced vibration of the retainer bars, resulting in tube-to-retainer bar contact.

The licensee determined that the lack of tube-to-retainer bar wear at anti-vibration bars 1 and 12, which are the same dimensions as the four previously discussed, was attributed to the lower flow velocity (7.5 ft/s) at the anti-vibration bar 1 location compared to the flow velocity (9.8 ft/s) at the anti-vibration bar 2 location. Mitsubishi failed to evaluate the potential effects of flow-induced vibrations during the anti-vibration and retainer bar design, due to assumptions that the natural frequency of the retaining bar was high enough to preclude flow-induced vibration. Mitsubishi failed to consider the effects of using retainer bars that were longer and of smaller diameter than those they had previously used.

During the design of the replacement steam generators, SCE questioned Mitsubishi on the lack of vibration analysis of the retainer bars but failed to independently evaluate the Mitsubishi response and agreed with the determination that the retainer bars would not come into contact with the tubes. Mitsubishi provided additional chromium plating of the retainer bars to reduce the wear coefficient and minimize potential wear in response to the licensee's questions.

The licensee's corrective actions included plugging 94 tubes in each of the Units 2 and 3 steam generators in the vicinity of the retainer. The licensee also stabilized 14 tubes in the Unit 2 and 12 tubes in the Unit 3 steam generators. For details about the retainer bar design noncited violation, please refer to NRC Inspection Report 05000361/2012010 and 05000362/2012010 (ML12318A342).

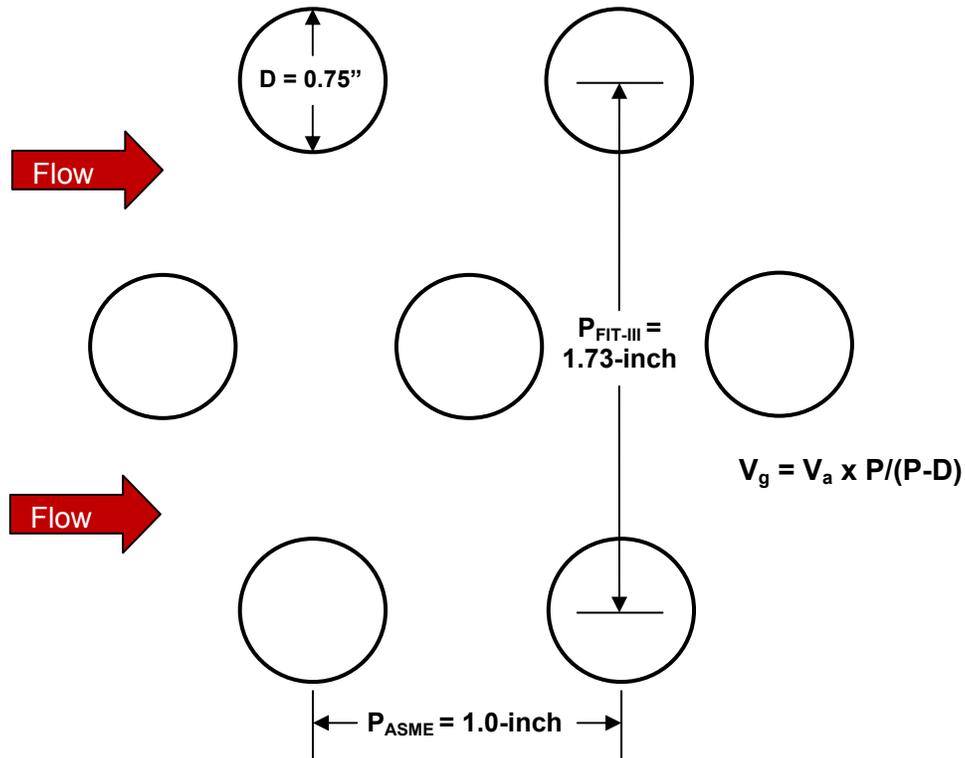
In response to this unresolved item, Mitsubishi identified that one of the factors responsible for the nonconservative flow velocities was that the flow area definition was not consistent with the recommendations in Appendix N (Mitsubishi Document L5-04GA591, "Validity of Use of the FIT-III Results during Design," Revision 1). Mitsubishi determined that the tube-to-tube gap used in the FIT-III thermal-hydraulic code, to determine the gap velocities, was larger than the recommended value in Appendix N, which resulted in lower calculated flow velocities. The difference in flow area definition is illustrated below. The tube array in the SCE replacement steam generators is a triangular array rotated 60 degrees, with a tube pitch of P = 1.0-inch. For that type of array, ASME BPVC, Section III, Appendix N, Figure N-1331-3, defines the tube pitch as the center-to-center distance between two tubes along the same column/row and in the longitudinal direction of the flow, which in this case would be

P = 1.0 inch. However, the flow area defined in FIT-III used the tube pitch in the transverse direction of the flow, which in SCE-rotated triangular array would be P = 1.73 inches. The use of a larger pitch in the FIT-III thermal-hydraulic analysis resulted in nonconservative calculated (lower) flow velocities.

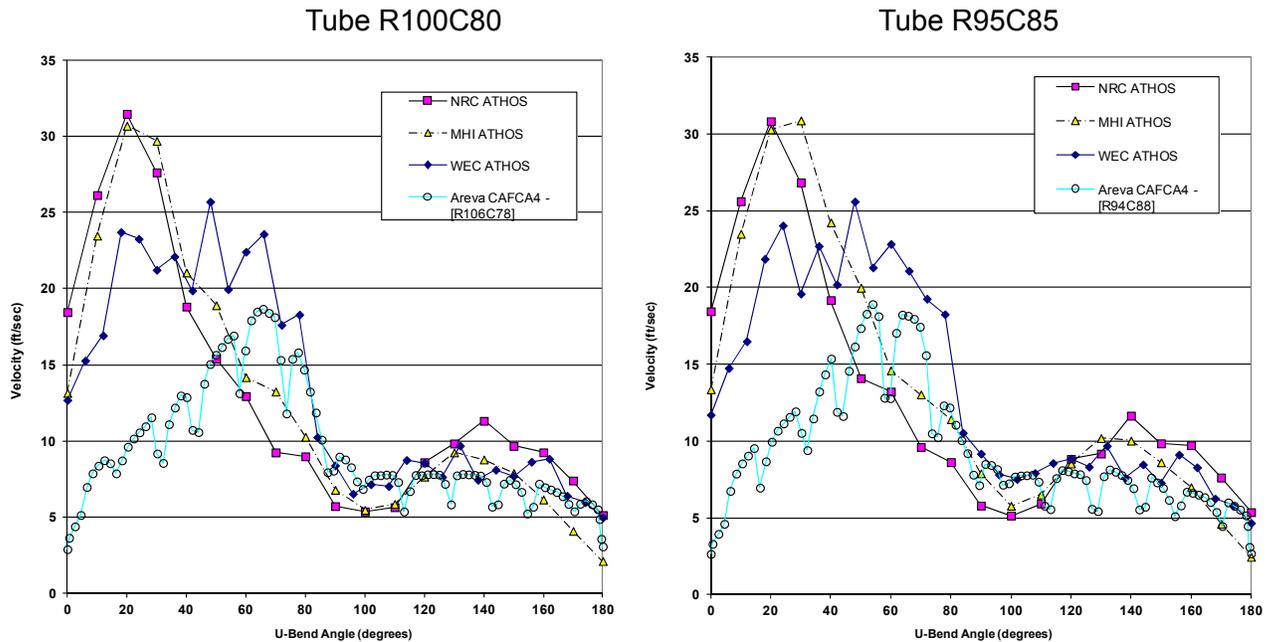
Figure 4: U-Bend Gap Velocities

more bulk boiling. Additionally, the wrapper transition opening is located in this region so there is an increase flow area and, consequently, increases in fluid velocities along the entire periphery.

The NRC and Mitsubishi results show the higher peak void fractions, which also peak at a lower location along the U-bend as compared to the Westinghouse and AREVA results. At higher angles along the U-bend, the void fraction predicted by each code tends to merge, and the remainder along the cold side tends to show very similar trends. As expected, comparisons of fluid density show similar trends as the void fraction. Dry saturated steam at about 850 psia has a density of about 2.0 lb_m/ft^3, and the NRC, Mitsubishi, and Westinghouse results predict that there are significant areas in the U-bend, in the affected region, where velocities are high and steam is nearly dry. Peak velocities and void fraction support the tube-to-tube wear patterns found in the Unit 3 steam generators. The inspectors concluded that the ATHOS code models are adequate to predict the approximate location and magnitude of the high void fraction and velocity, which are the key contributors to tube-to-tube wear found in the U-bend region.

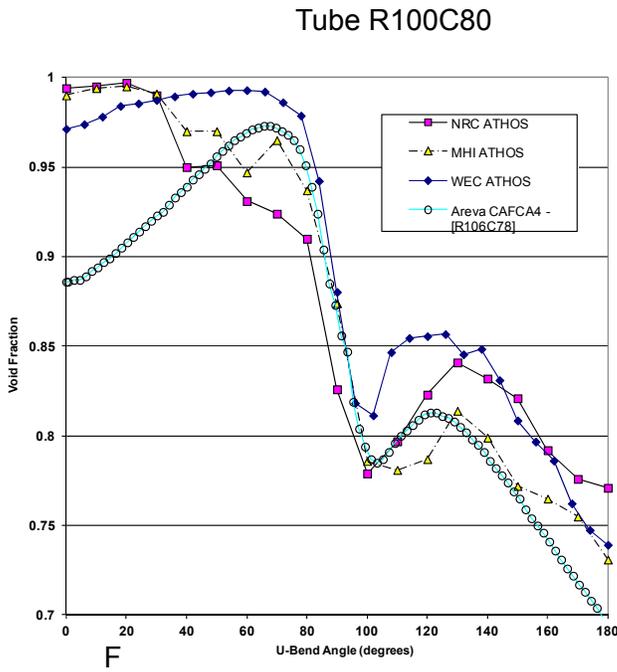
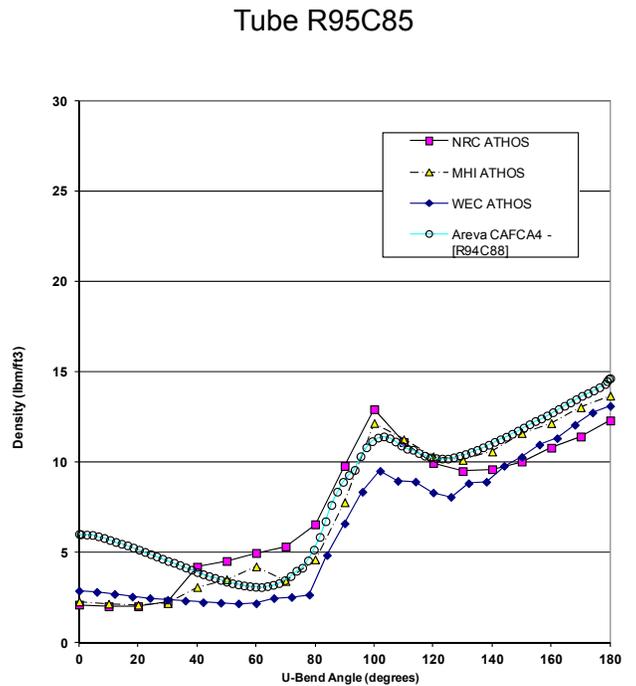
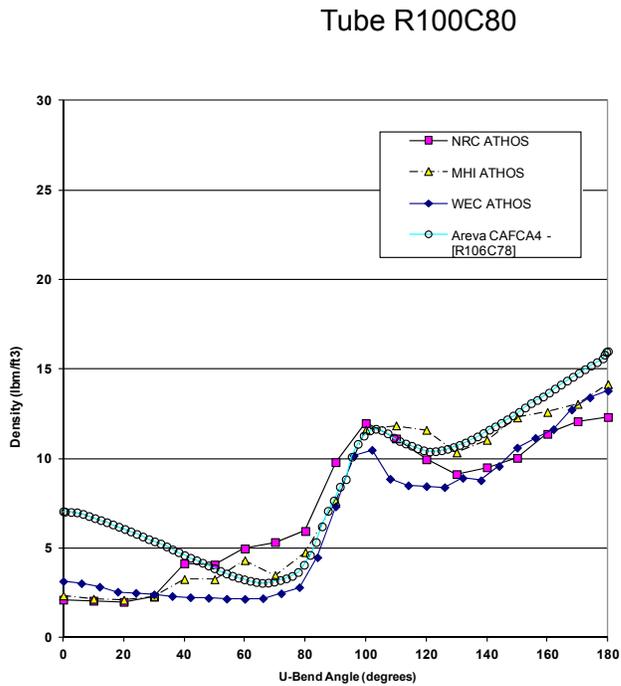
Tube R100C80

Tube R95C85

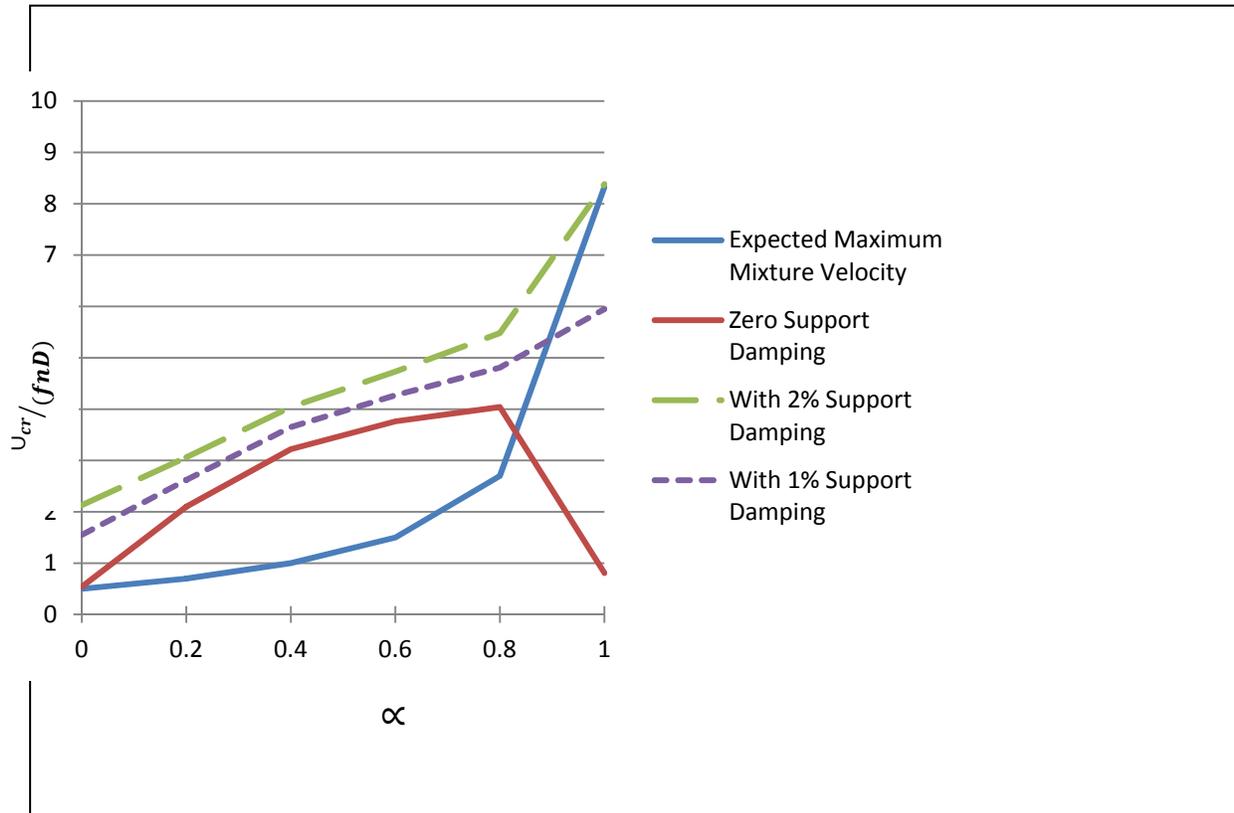
Fig. 1 Critical velocity for onset of FEI as a function of void fraction.

The calculated dimensionless critical velocity for onset of FEI is plotted in Fig. 1 as a function of void fraction, with or without support damping. In this figure the expected two phase mixture velocity through the steam generator (RSG) tube bundle is also plotted as a function of $\propto$ for an assumed two phase mass flow rate of $65 lbm / ft^2/sec$ or $315 kg/m^2/sec$ and natural frequency of 34 sec.[-1] It is noted that for void fractions less than 0.8 in the U-bend region of the bundle (for cross flow), the critical velocity for onset of instability is higher than the mixture velocity. As such probability of onset of FEI will be low. However, for void fractions greater than 0.8, the mixture velocity can be substantially higher than the critical velocity, indicating a strong possibility of occurrence of FEI. In RSGs for Units 2 and 3, there is a significant area in the upper U-bend region where calculated void fractions exceed 0.8. When support damping of 1% and 2% is included, the predicted dimensionless critical velocity for onset of FEI increases for all values of $\propto$. However, the increase is substantial for high void fractions (greater than 0.8) because now the support damping dominates viscous and two phase damping. With support damping of 1%, the two phase mixture velocity can

exceed the critical velocity for onset of FEI when the void fraction approaches unity. (Although this is not the case for the results plotted in Fig. 1 when support damping of 2% is included in the calculations.) Thus to reduce the propensity of FEI it is essential that very high void fraction regions ($\propto \simeq 1$) in the upper U-bend region of RSGs should be avoided. Figure 1 can be used to determine for individual tubes or clusters of tubes the potential for FEI in Units 2 and 3 RSGs. It should also be noted that lack of contact forces and damping due to anti-vibration bars may be the dominant reason for existence of FEI and severe tube damage in Unit 3 RSGs. As a result of FEI, initially out-of-plane vibrations are expected to occur in the lift direction normal to plane of the tubes. However, this instability in the absence of restraining force from anti-vibration bars can excite in-plane vibration that can be the cause of tube to tube damage.
