INTRODUCTION

San Onofre Nuclear Generating Station (SONGS) performed a visual assessment of three multi-purpose canisters (MPCs) from March 21 - 23, 2019. This report includes the following:

SONGS HI-STORM MPC Visual Assessment Report

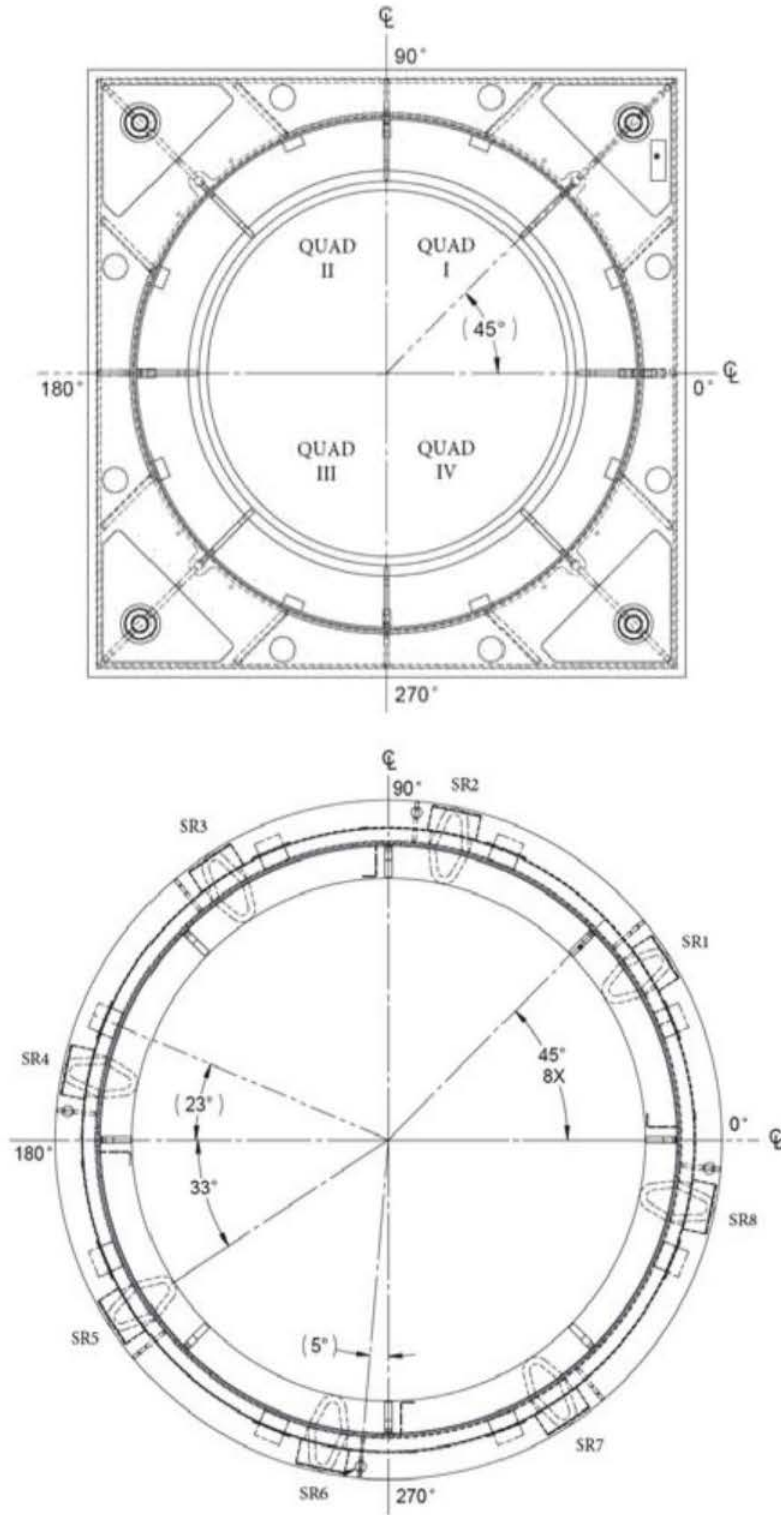
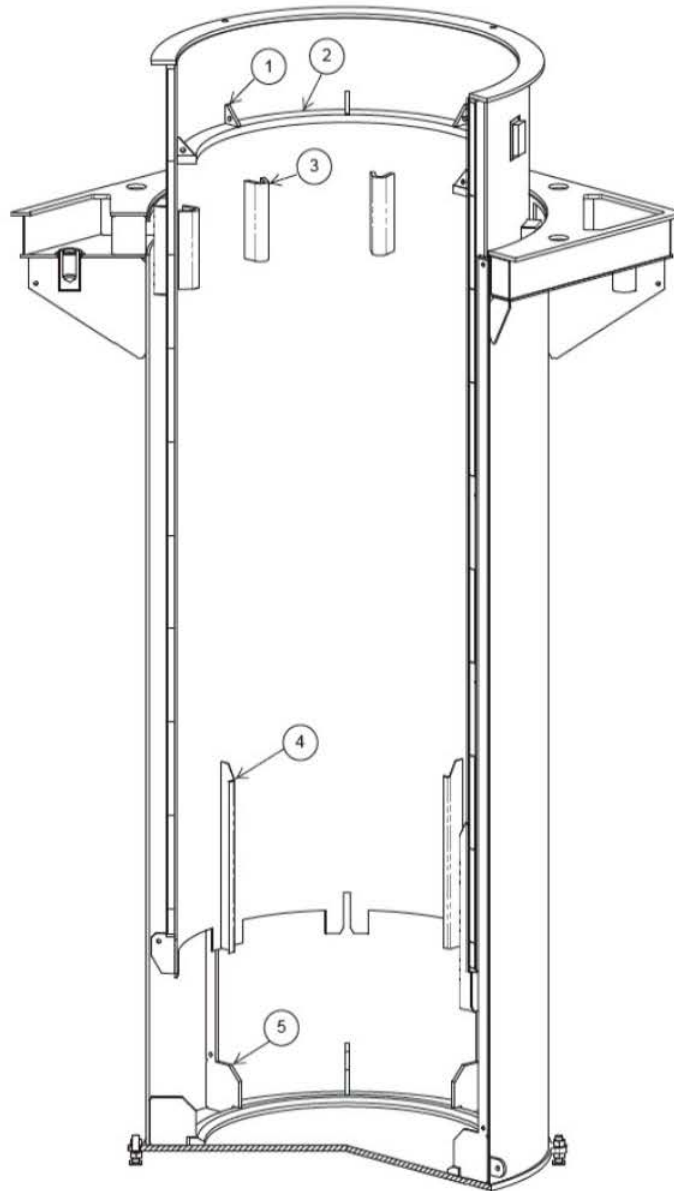
Cavity Enclosure Container and Divider Shell Reference Information

- 1 Divider Shell Shield Ring Guide
- 2 Divider Shell Shield Ring
- 3 MPC Inner Seismic Restraint (also referred to as upper seismic restraint)
- 4 Divider Shell MPC Guide Cover
- 5 Lower MPC Guide / CEC Baffle (also referred to as lower seismic restraint)
